| | Bushfire Mitigation Plan MN-PM-PLN-0064 | Version 7.3 | Effective Date:<br>03 Sept 2026 |

# MOORABOOL WIND FARM PTY LTD

## Bushfire Mitigation Plan

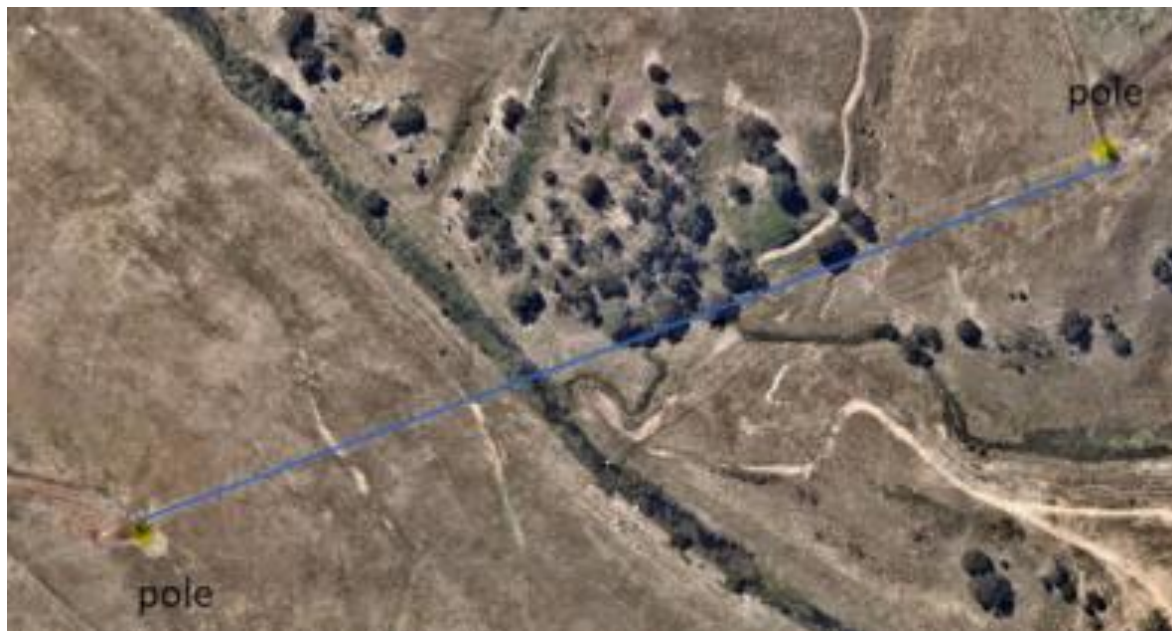
The at-risk line consists of two 14-metre-high galvanized steel poles attached to guy wires, containing a single circuit (3 phase) 33kv overhead line measuring 429.42 metres in length above the MREB as shown in Figure 2.1. This is the only Overhead Line (OHL) that GWA has responsibility for at either of the Moorabool sites and is the short section (429m) of single span 33kV OHL between the substation and Collector Feeder 4. The Plan applies to land within a High Bushfire Rated Area (HBRA). Overhead lines were installed in September 2019.

*Figure 7.1 Location of the Overhead line and poles across the Moorabool River East Brach*

There is a 429m section of OHL spanning a gully in Collector Group 4. The phase conductors are arranged in a flat configuration with a spacing of 1.4m between phases. The OHEW is run 1.5m directly above the centre conductor. The line is modelled with phase conductors 10.5m above the ground. The OHEW is modelled as 'grape' as final design has not been completed.

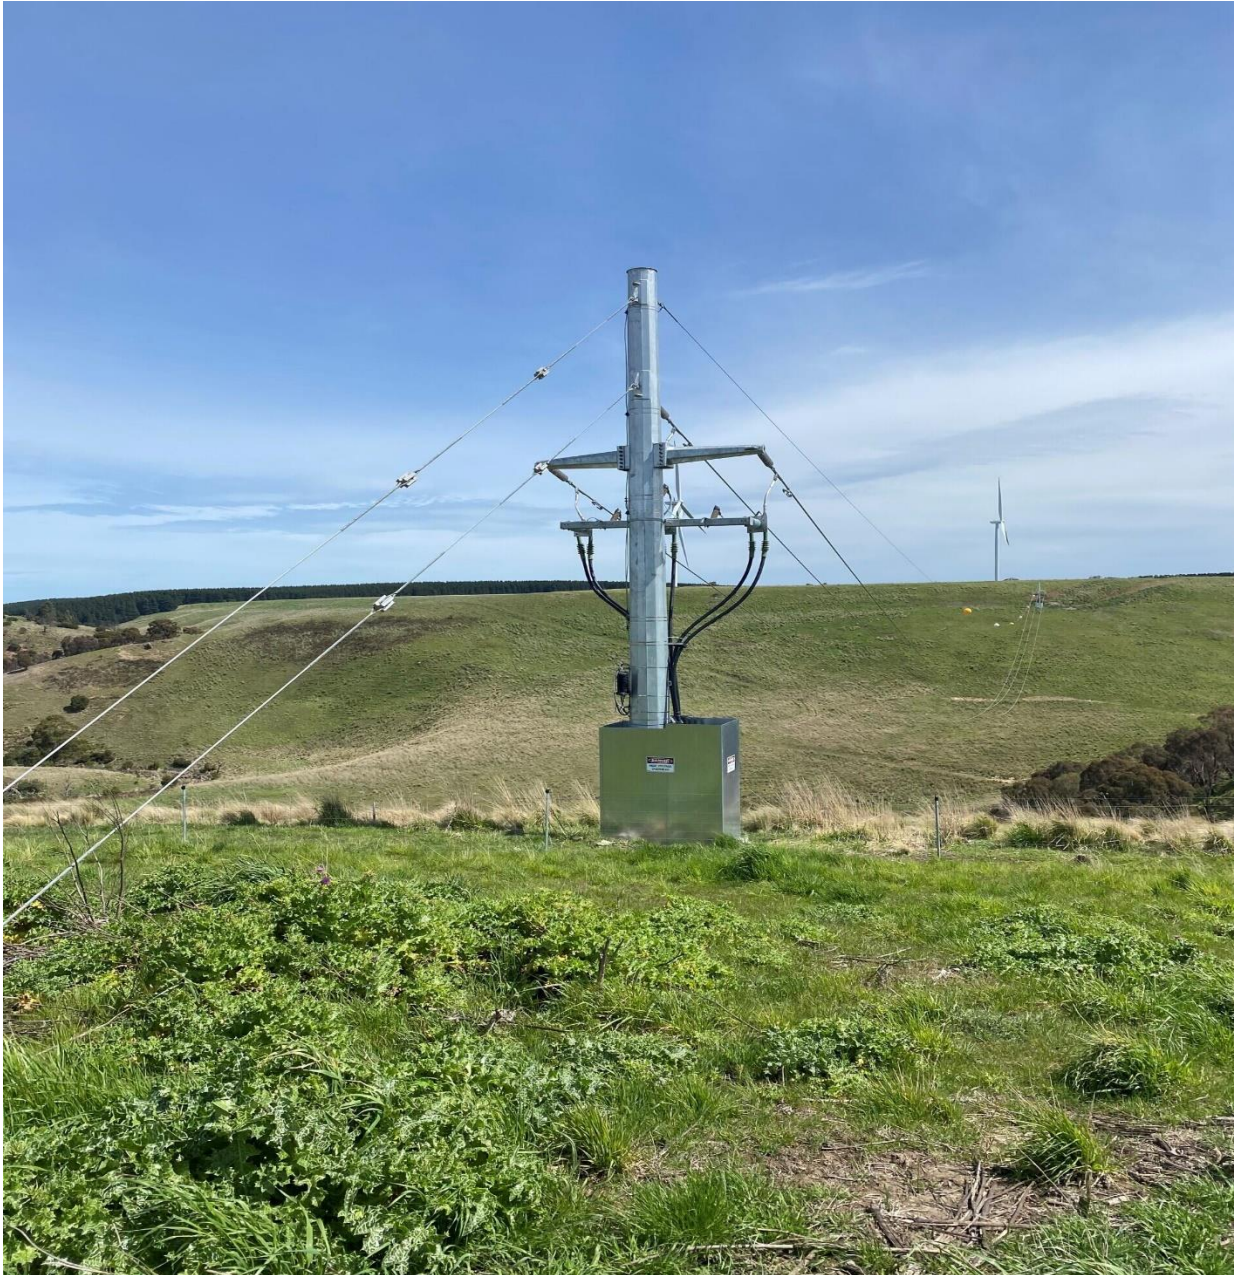
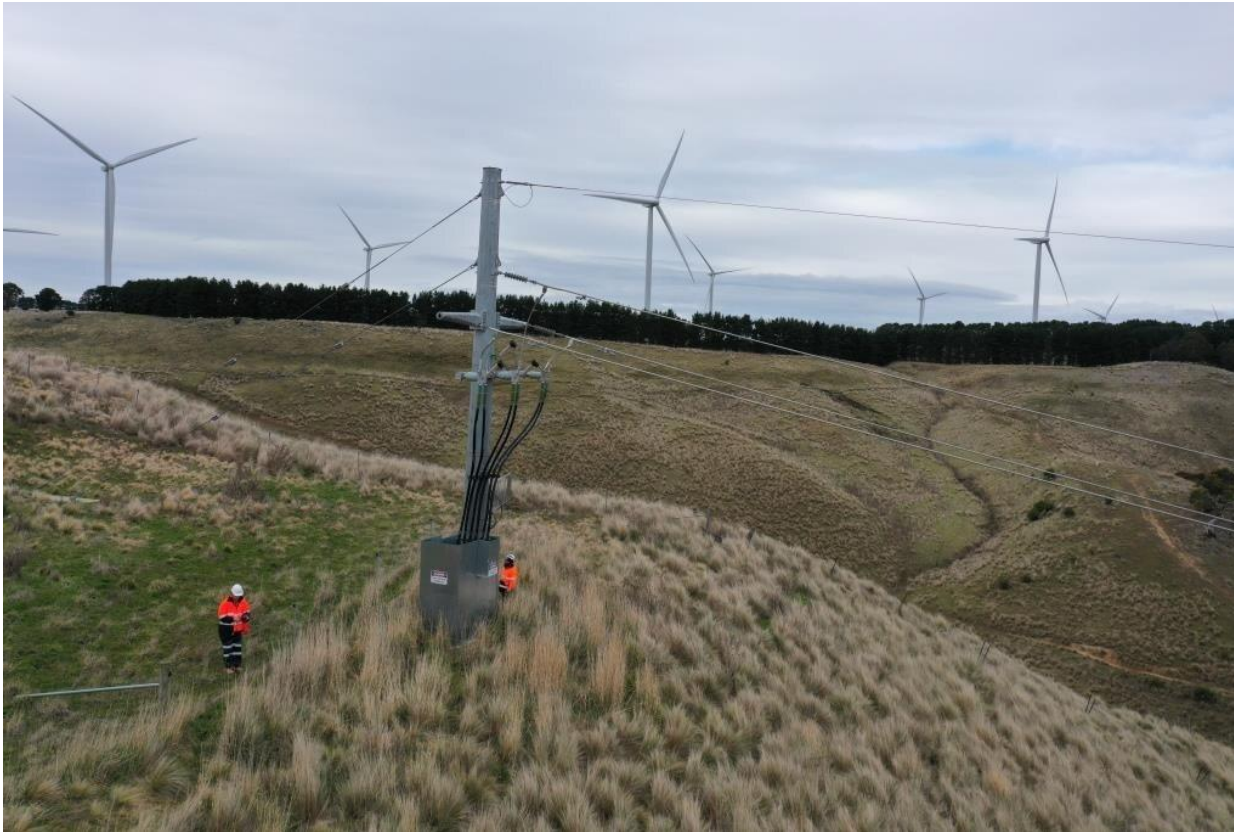
**33 kV Overhead Transmission line spanning MREB (T29 to T34) – Representative images**  
**1. Eastern Tower Structure and Span**

Eastern Tower Structure - 33kV Overhead Line

Four structures were visually inspected for defects during the assessment and no high priority defects were identified. Two capsules were assessed as having surface rust, but not present as issue only an observation.
